CALIFORNIA STATE UNIVERSITY, NORTHRIDGE

POST-FIRE DEBRIS FLOW EROSION
IN THE SAN GABRIEL MOUNTAINS, CALIFORNIA:
EVIDENCE FROM THE STATION FIRE, 2009

A thesis submitted in partial fulfillment of the requirements
For the degree of Master of Science
in Geology

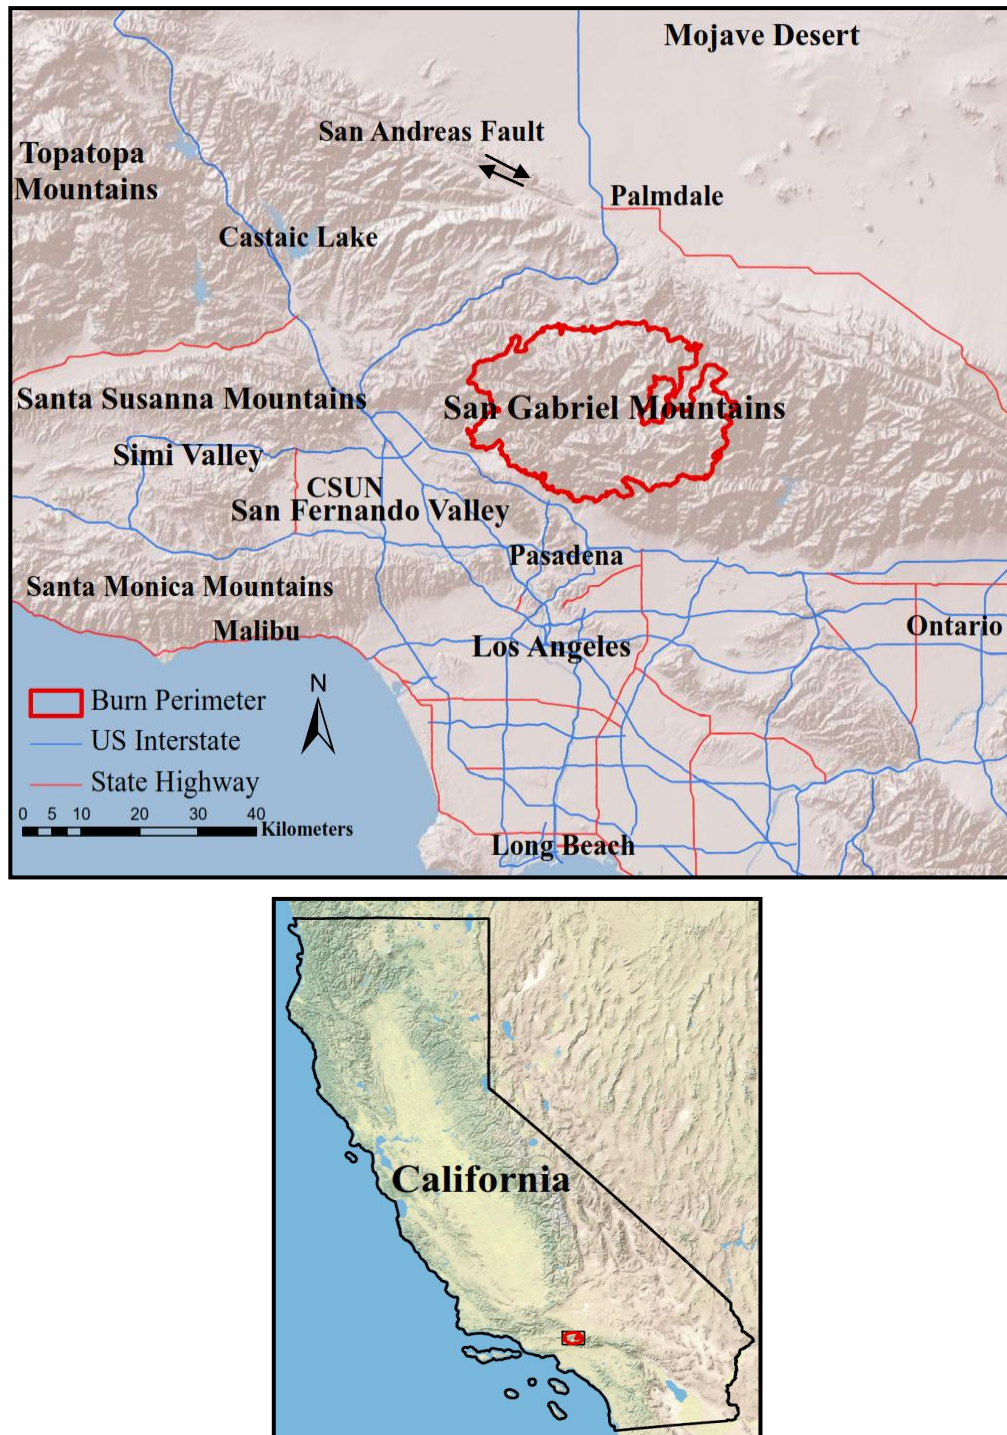
Location Map of San Gabriel Mountains

Figure 4. Reference location map of San Gabriel Mountains with the Station Fire burn perimeter. The shaded relief imagery was developed by ESRI using GTOPO30, Shuttle Radar Topography Mission (SRTM), and National Elevation Data (NED) data from the USGS. The burn perimeter shapefile is courtesy of the U.S. Forestry Department.

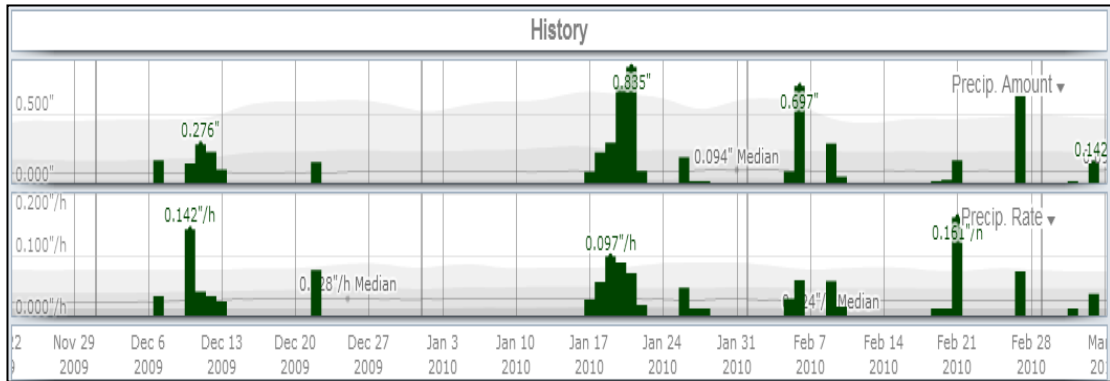
Figure 5. Rainfall history from November 2009 – February 2010 for San Gabriel Mountains totaled over 760 mm measured at San Gabriel Mountains weather station (see location on Figure 9) (downloaded from weatherspark.com)

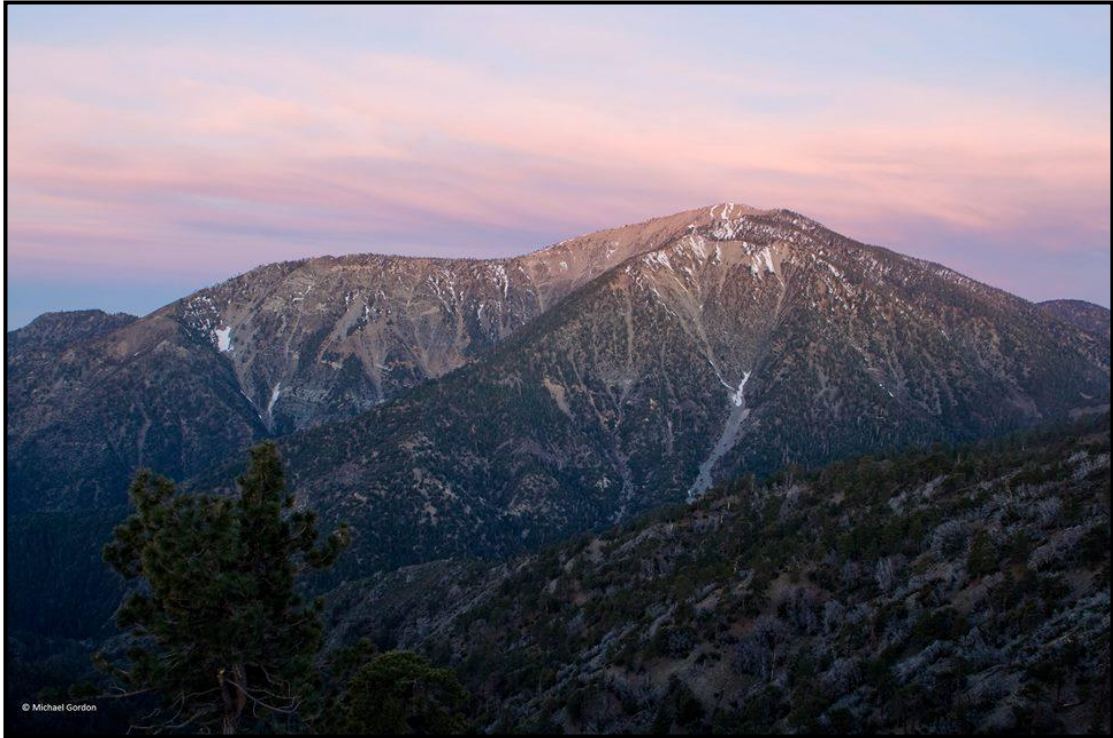
View of the San Gabriel Mountains to the North

Figure 7. View of the steep-sided slopes of the San Gabriel Mountains to the north (Michael Gordon, 2013)

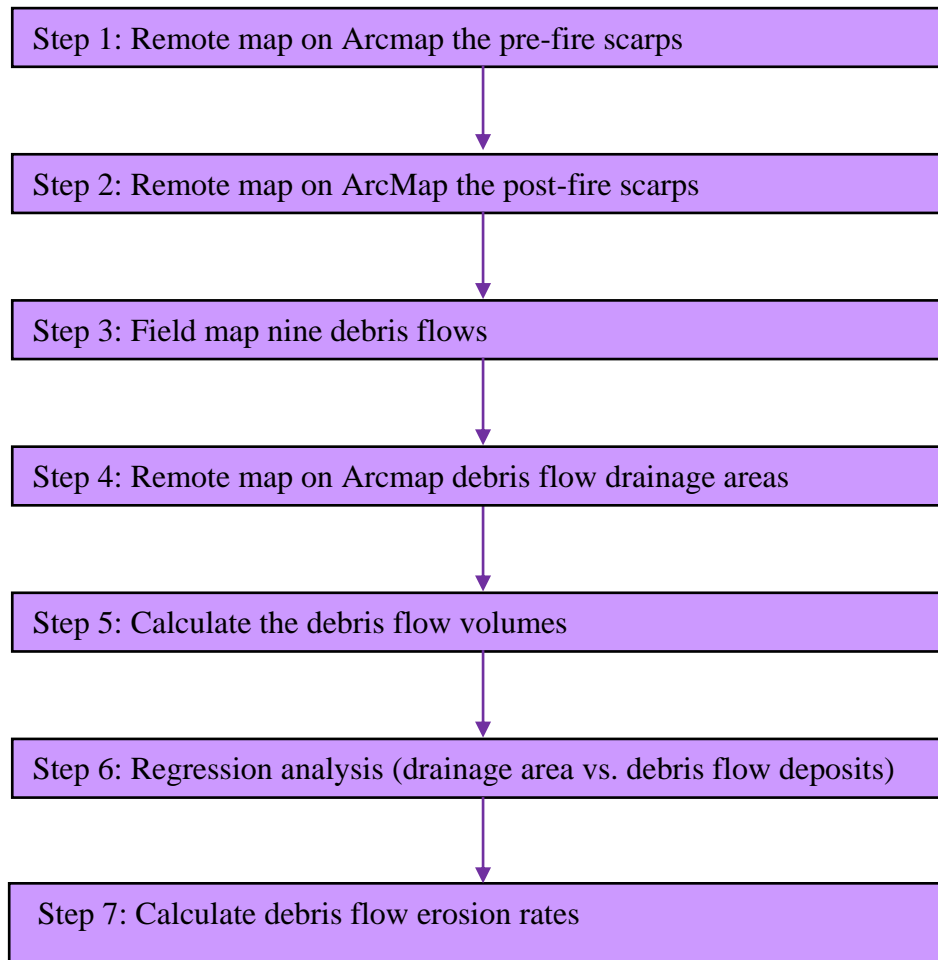
Figure 10. Step by step process for analysis of Station Fire (2009) debris flows

Figure 10 illustrates the overall workflow to accomplish this goal. Step one was to utilize remote imagery to map the pre-fire scarps from earlier debris flows from imagery obtained from July 2009. Step two involved remote-mapping of debris flows that occurred shortly after the Station Fire in late 2009 and early 2010 (based on imagery taken from April to September 2010). Step three involved field mapping of nine selected debris flows to determine the transition areas from erosion to deposition, to measure the volumes of debris flow deposited, to measure the slope where the flows commenced deposition, and to conduct lithological analyses. Step four involved remote mapping of the drainage systems for each debris flow. Step five involved the calculation of debris volume from the measured debris flows. Step six involved a regression analysis of the mapped flows and extrapolation of this regression to all the remotely mapped flows within the study area. In step seven, the final step, the approximate erosion rates due to these types of debris flows were calculated.

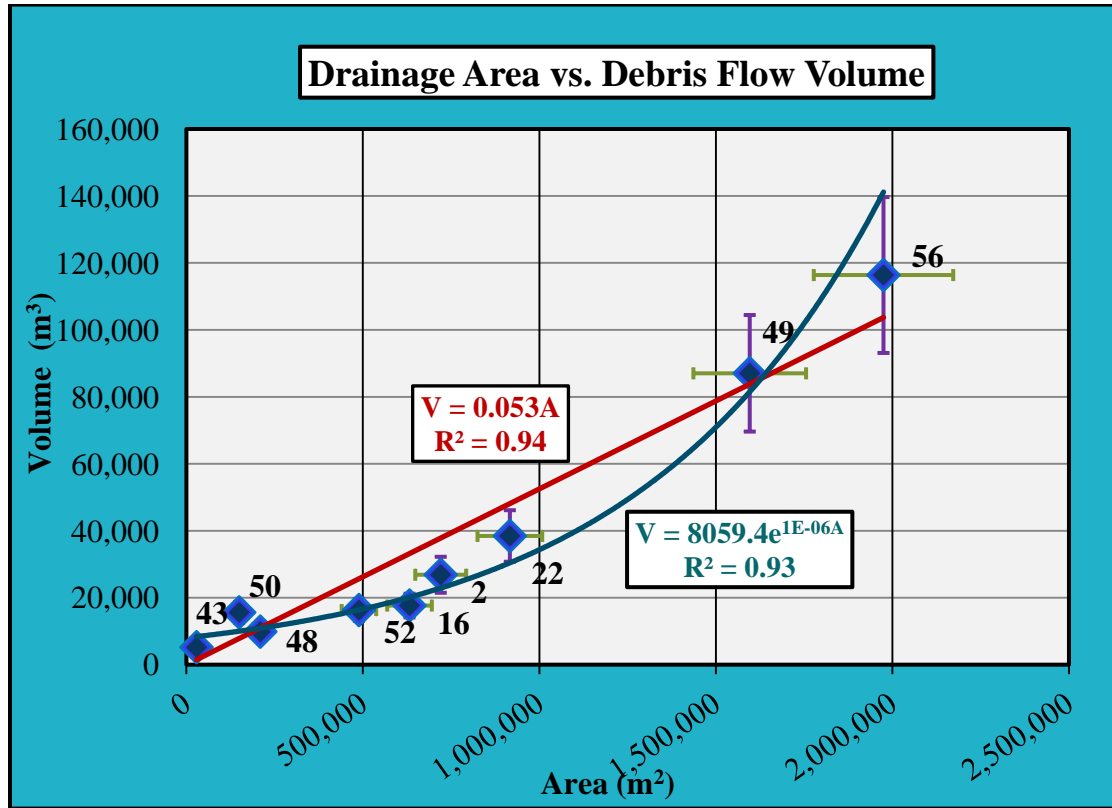
Figure 18. Debris flow drainage area vs. debris flow deposition volume showing linear regression relationship in red line and exponential regression relationship in green curved line with standard error bars.

A regression analysis using the new volume calculations was used to determine the relationship between debris flow drainage area and the debris flow depositional volumes. This regression analysis gives an estimate of the amount of debris flow deposition given a debris flow drainage area and revealed a linear relationship between the debris flow drainage area per flow covered by the debris flow and the volume of deposition per each flow (Figure 19). Equation 6.1 fits the observed correlation in a linear relationship ($R^2 = 0.94$). Equation 6.2 also fits the observed correlation in an exponential relationship ($R^2 = 0.93$). Both regression expressions (linear and exponential) have excellent accuracy.

This data analysis reveals a linear coefficient of 0.053 ± 0.01 for debris flow drainage area vs. sediment deposition volume for post-fire debris flows and demonstrates that, given a certain area in a burnt steep mountain terrain, the post-fire debris flows will produce a calculated sediment deposit. This value is useful in predicting the amount of sediment that may be deposited after debris flows in a burnt canyon with a debris flow in the SGM, is useful to assist in predicting debris volumes from post-fire debris flows, and is useful to for planning debris dam development and expansion. Using this simple regression analysis, this coefficient value could be utilized to help prevent damage to state, federal, and personal property by anticipating the debris volume expected and implementing hazard precautions for roads, populated areas, and biological environments affected by debris flows. This would potentially help save thousands of taxpayers' dollars in clearing away debris and the damages done to private and public property due to post-fire debris flows.

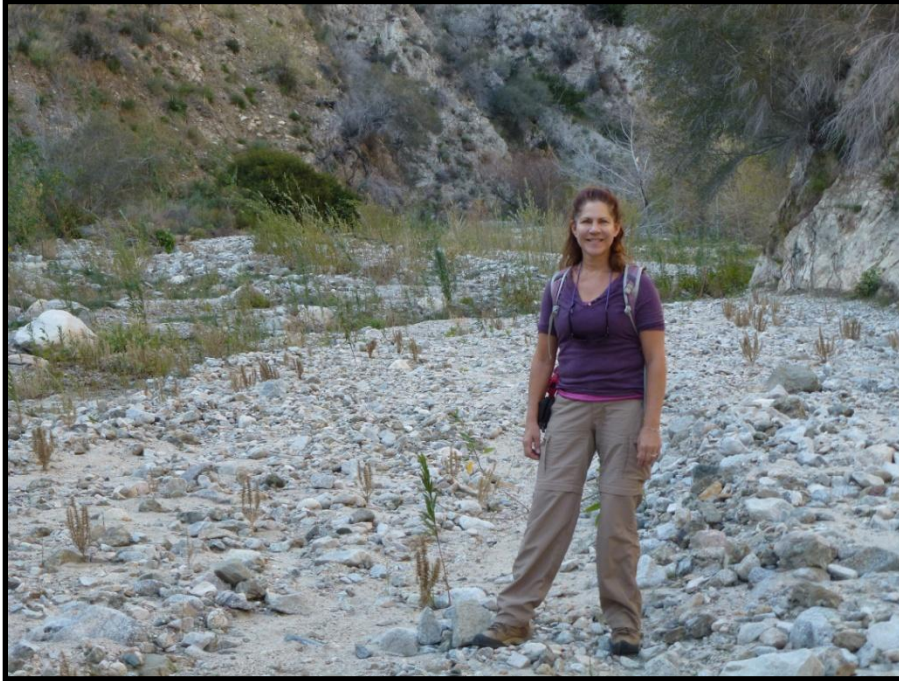
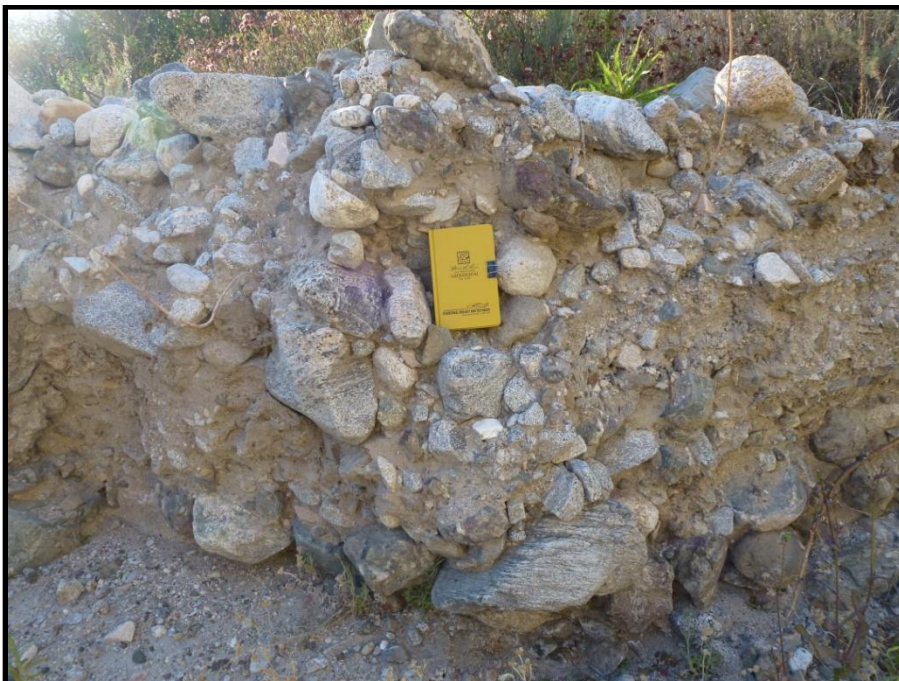
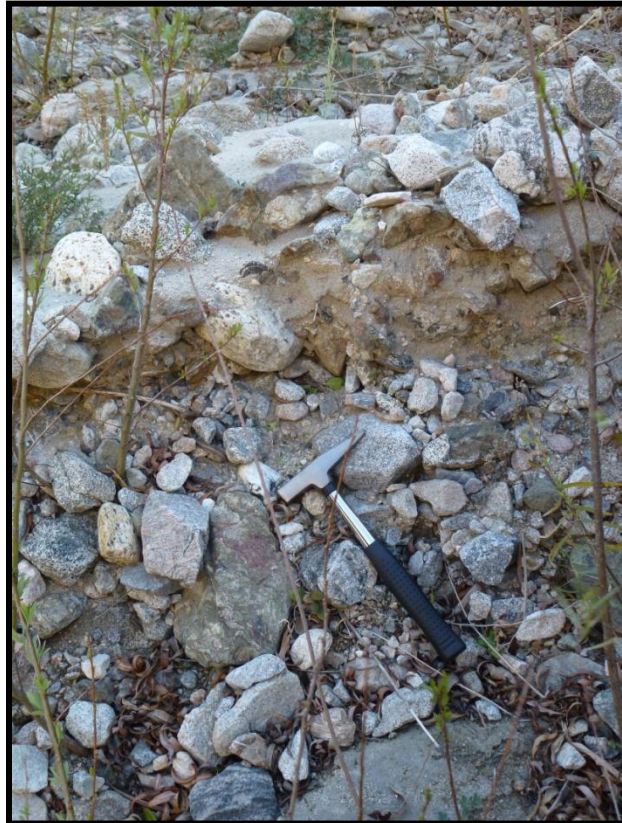
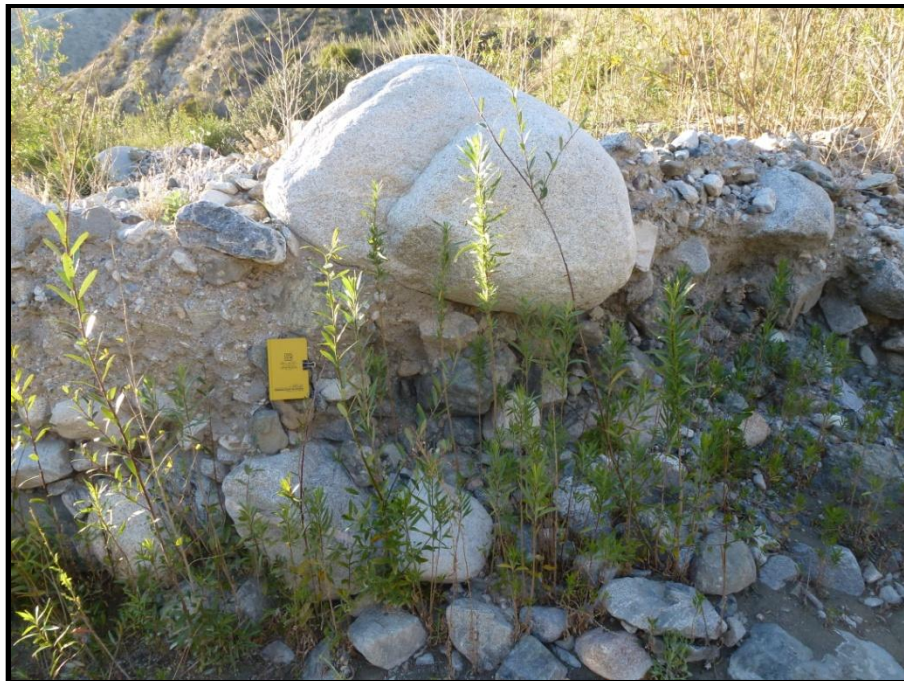
Figure 1. Debris flow 2 (Gold Canyon)

a. Debris flow 2 - looking north up canyon

b. Debris flow 2 deposit - east, middle deposit

c. Debris flow 2 deposit - west, middle deposit

d. Debris flow 2 deposit - near the flow toe

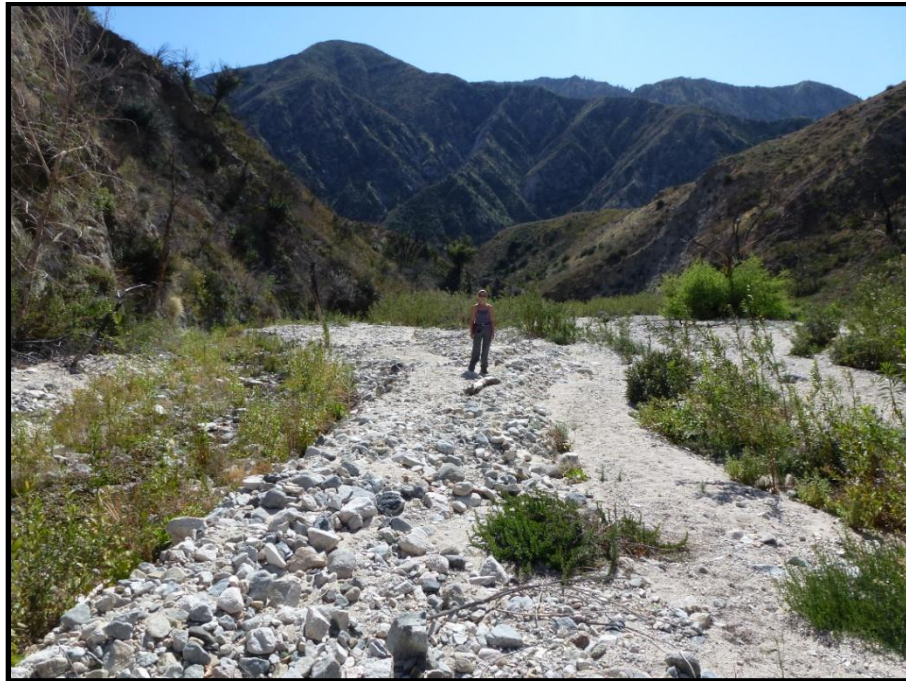
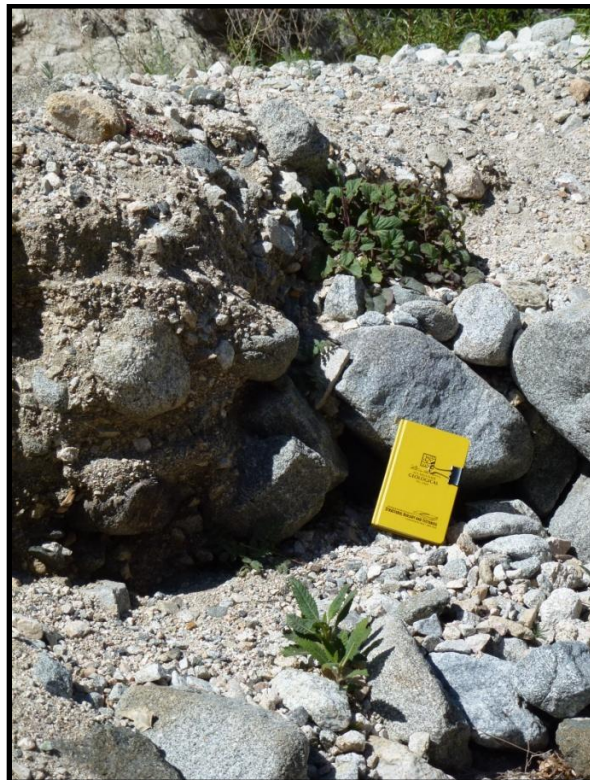
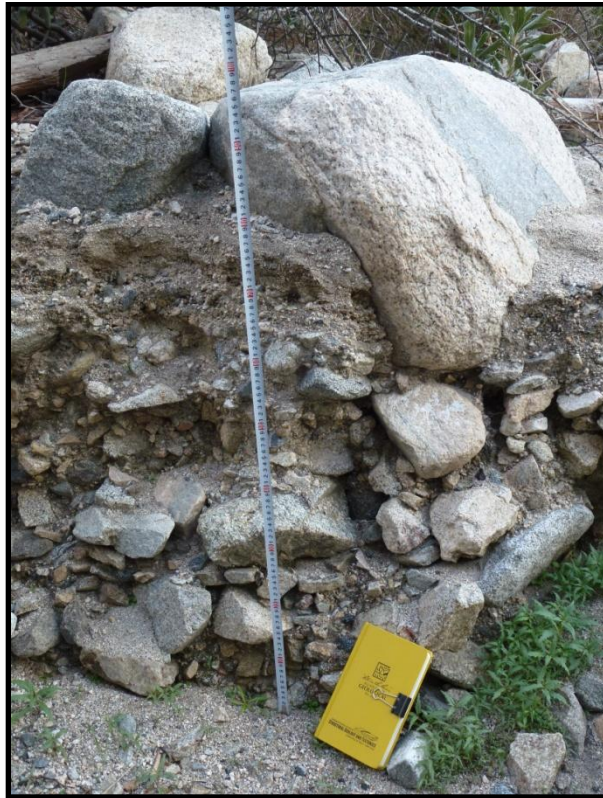
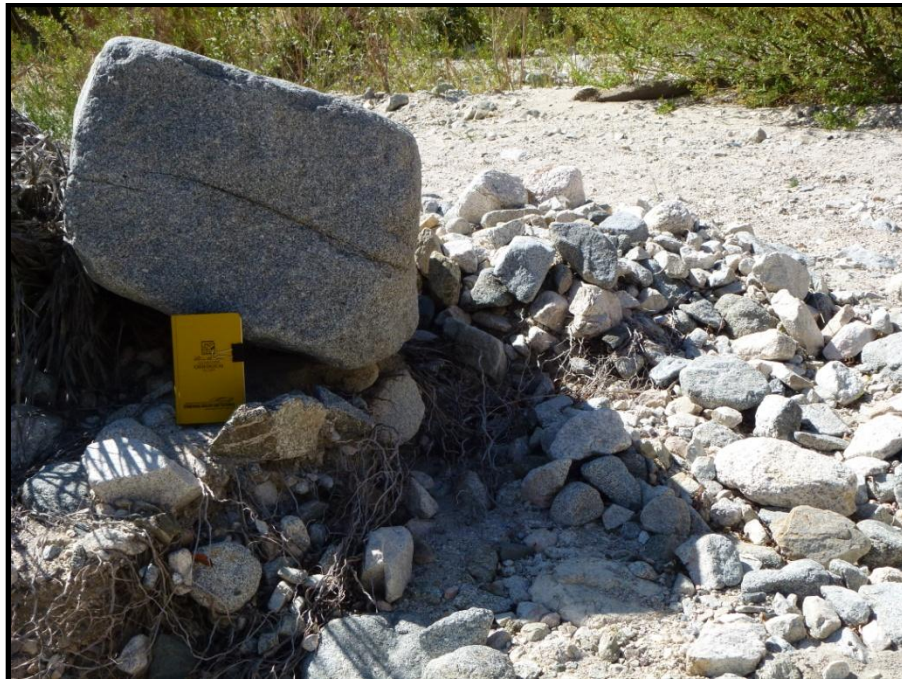
Figure 2. Debris Flow 16 (Ybarra Canyon)

a. Debris flow 16 - looking up northeast

b. Debris flow 16 deposit - middle of flow deposit

c. Debris flow 16 - middle deposit, depth - 97 cm

d. Debris flow 16 deposit - near the flow toe

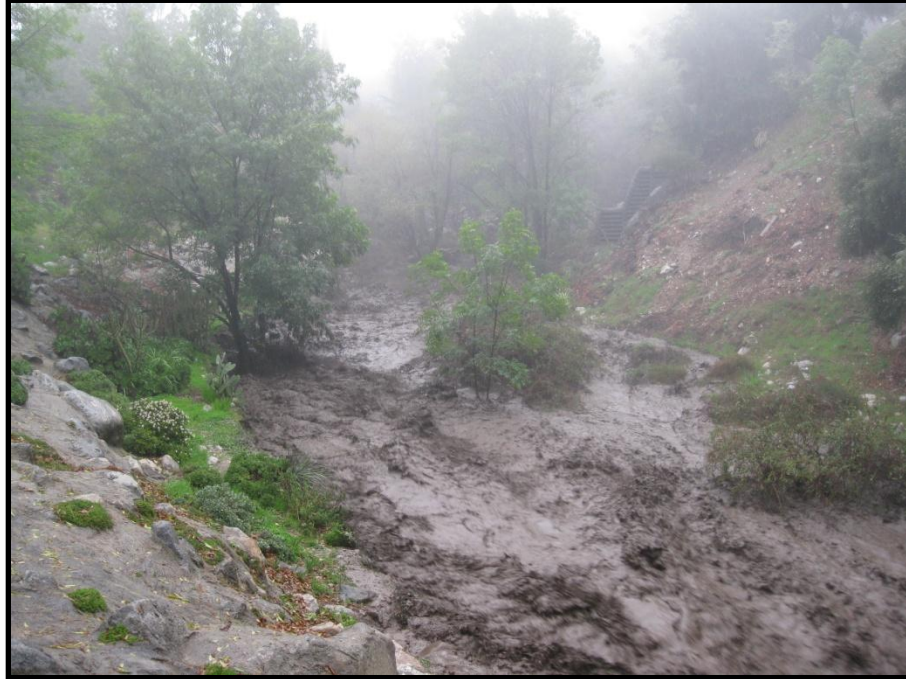
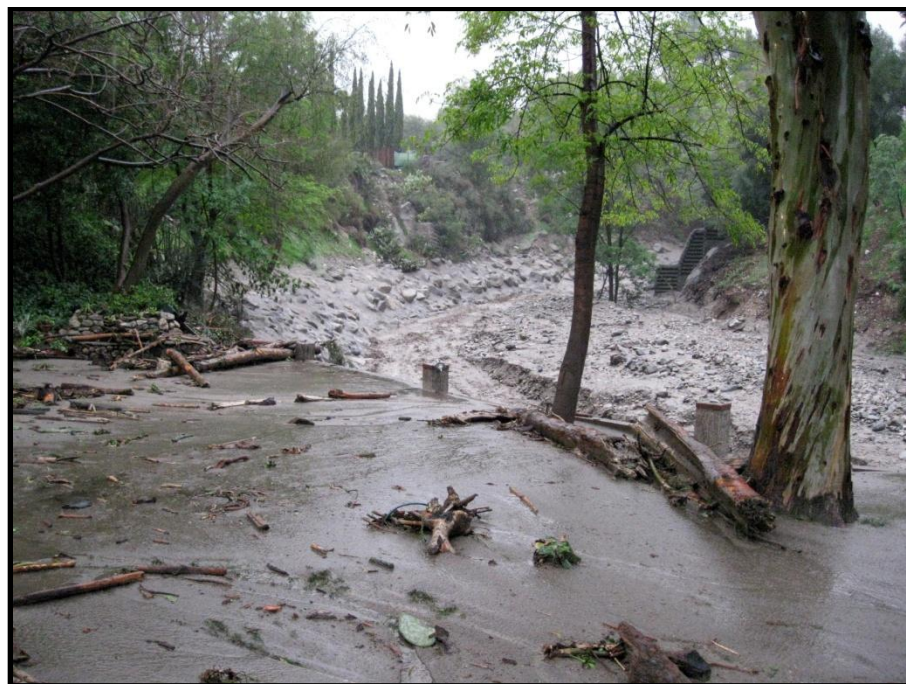
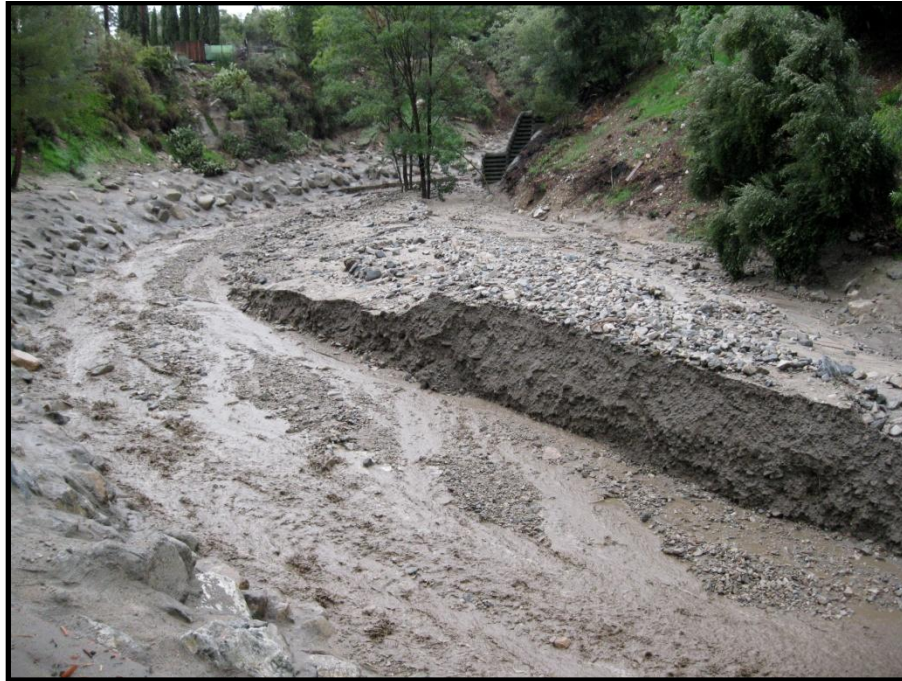
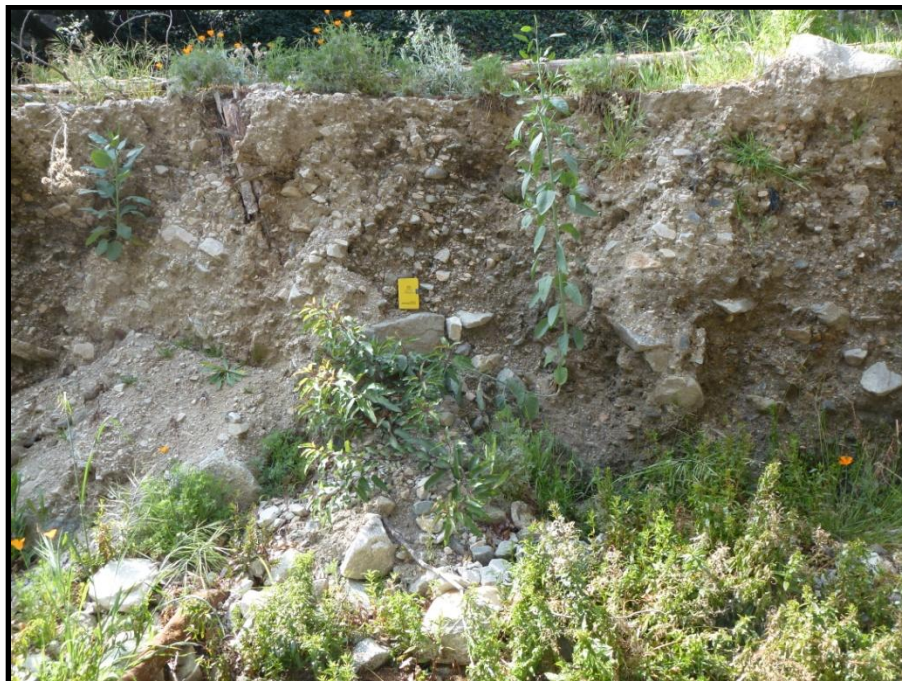
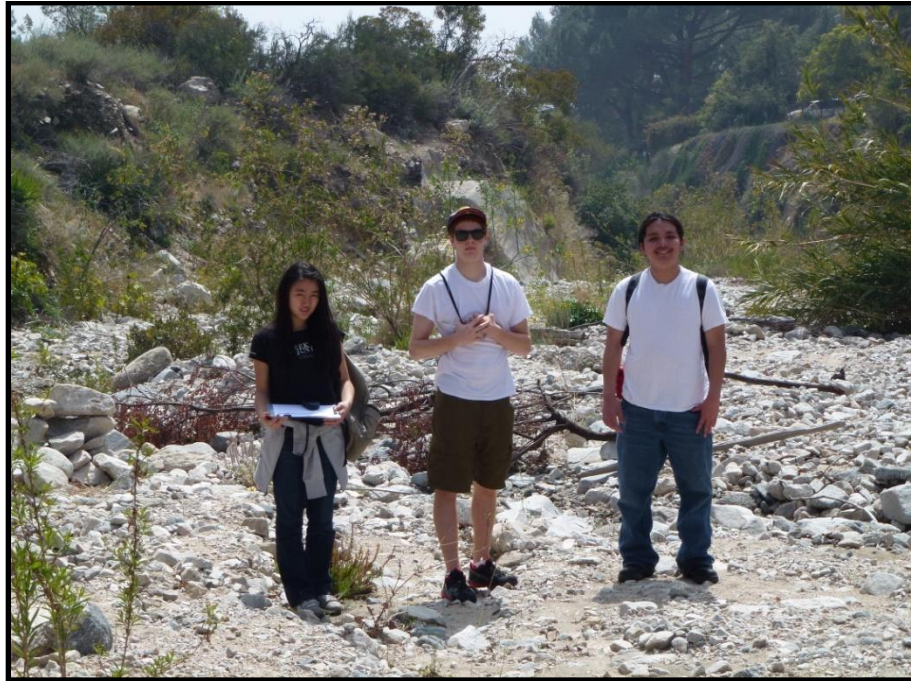
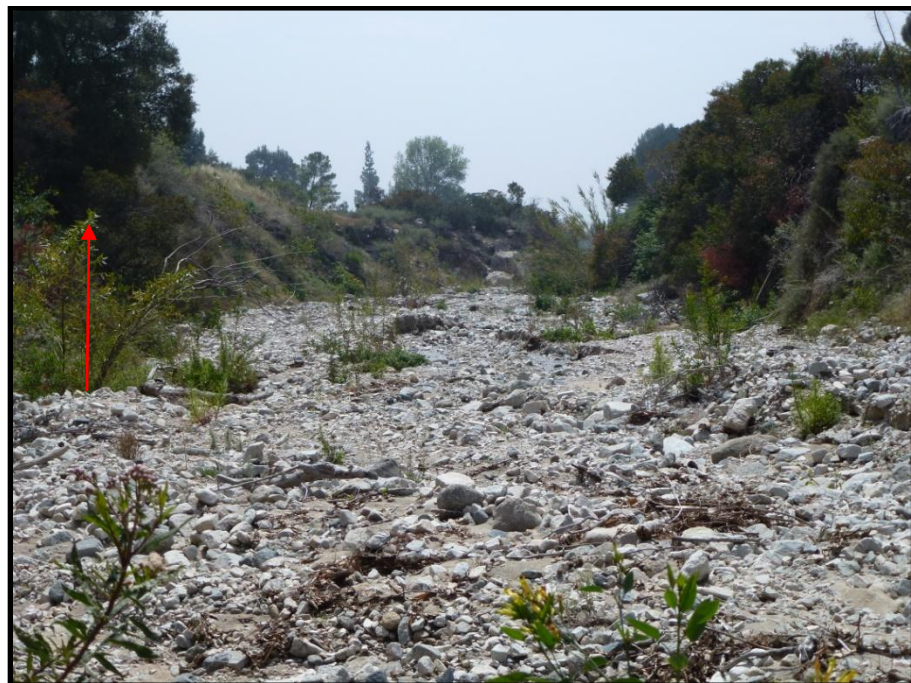
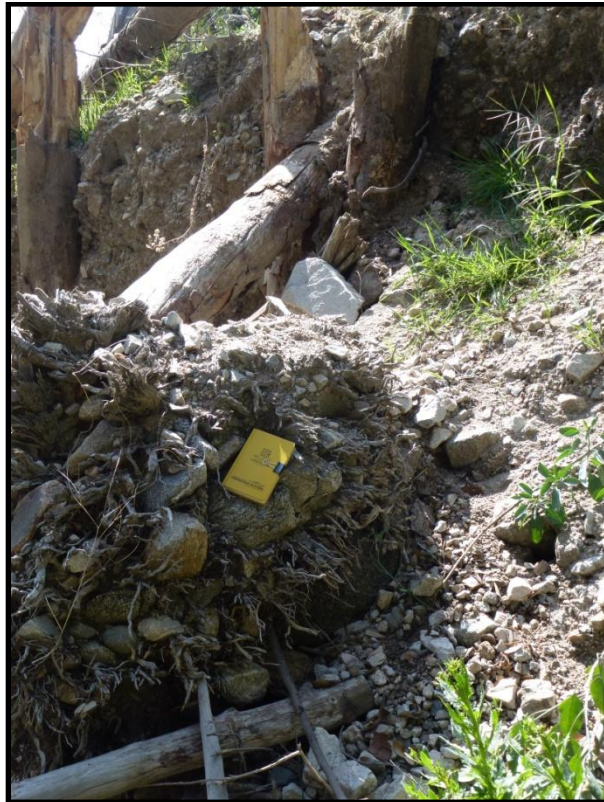
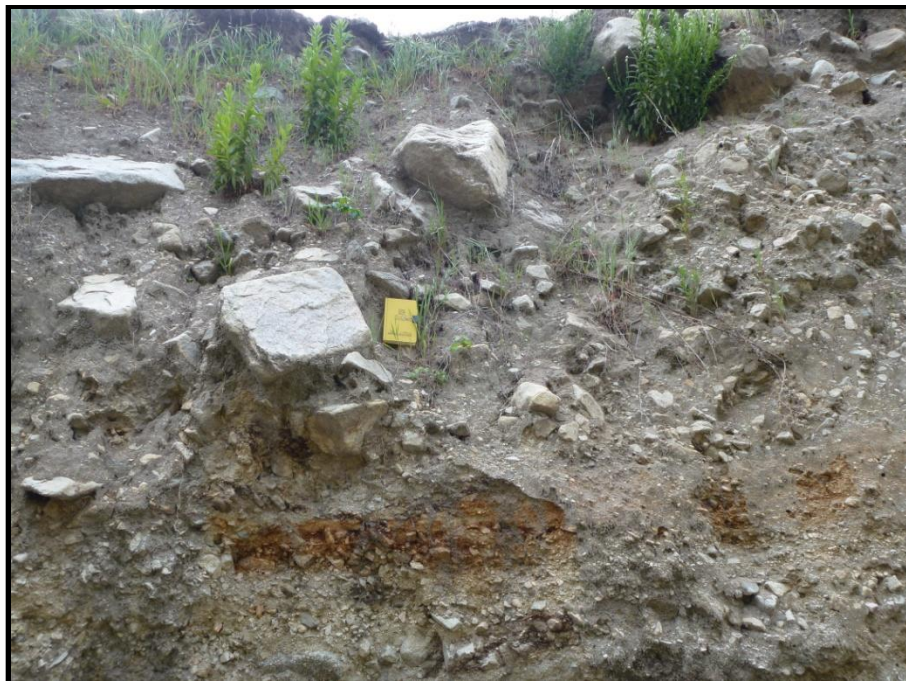
Figure 3. Debris Flow 22 (Pickens Canyon)

a. Active debris flow 22 view to north, mid-flow - taken by Carol Lewis from her La Canãda-Flintridge home on 02/16/10

b. Active debris flow 22 view to northeast, mid-flow - taken by Carol Lewis from her La Canãda-Flintridge home on 02/16/10

c. Active debris flow 22 view to northeast, mid-flow, closer view of deposits - taken by Carol Lewis from her La Canãda-Flintridge home on 02/16/10

d. Flow 22 deposit - west middle deposit

e. Debris flow 22 - looking south down flow deposits, field assistants: Joy Lee, Nathanael Ahlstrom, and Robert Dario from Morning Star Christian Academy

f. Debris flow 22 - looking down (south), bush to the left center is 2.3 m high

g. Debris flow 22 deposit - northwest view - center of deposit

h. Debris flow 22 deposit - northeast view - center of deposit

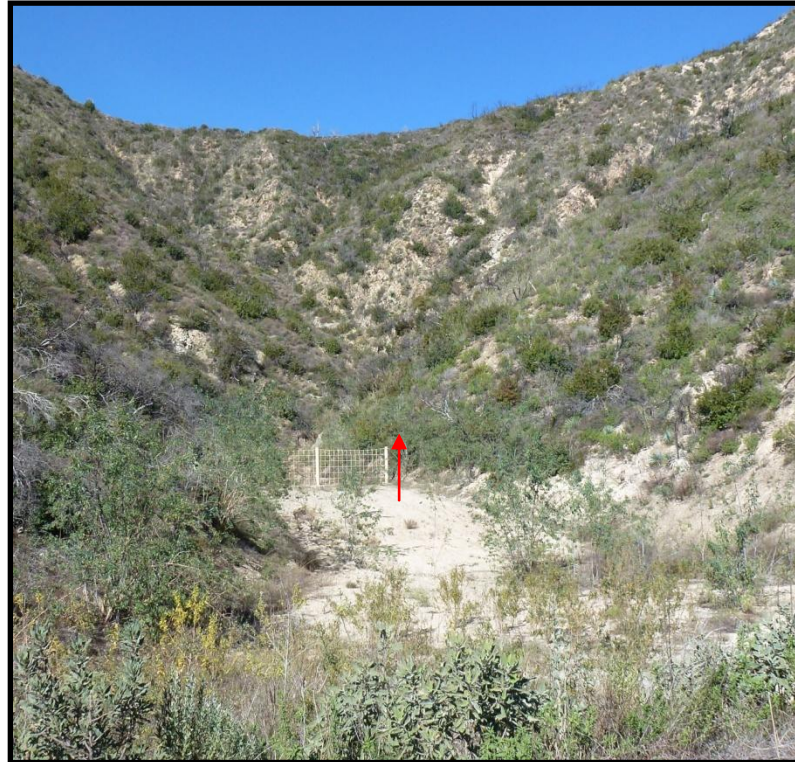
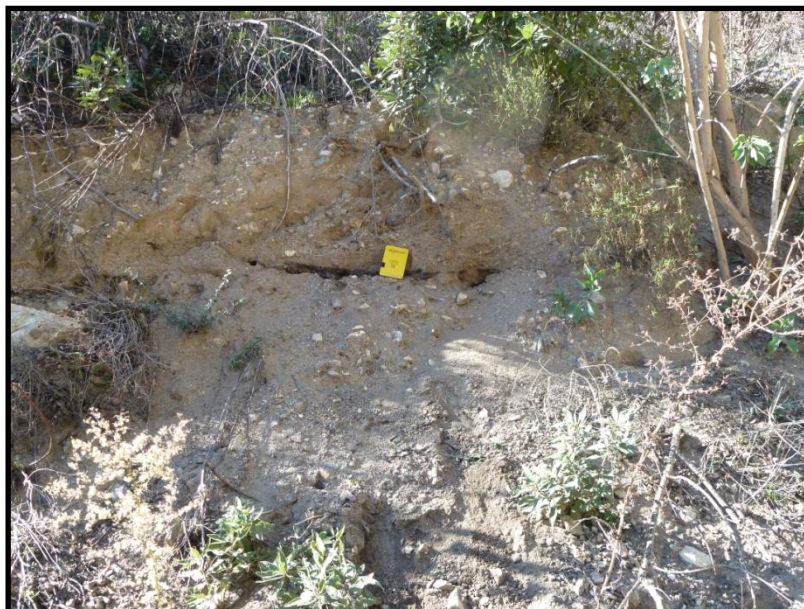
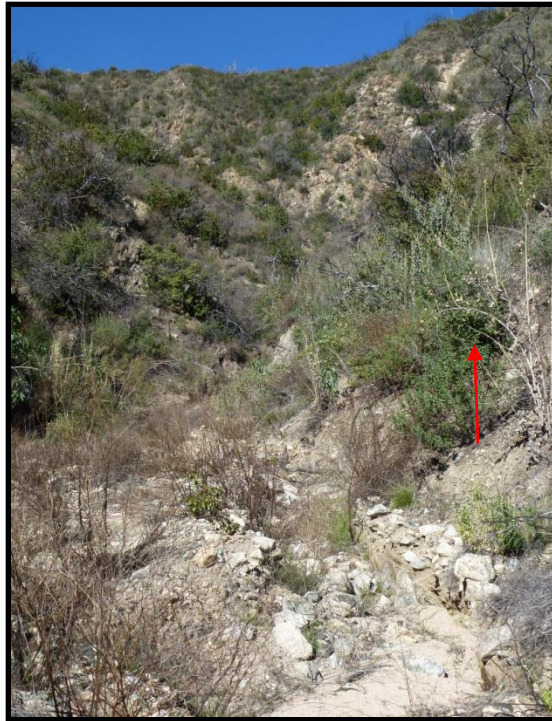
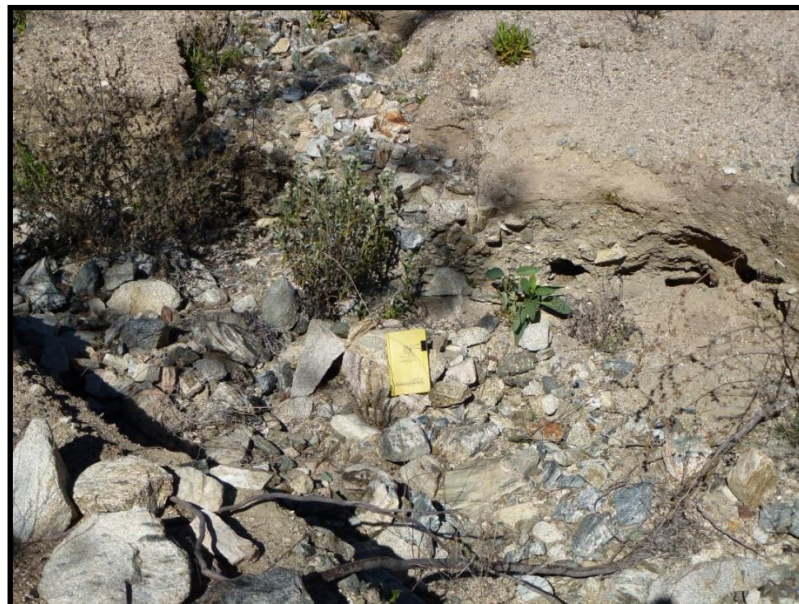
Figure 4. Debris flow 43 (Dark Canyon)

a. Debris flow 43 - looking north from Highway 2 - debris flow fence is 2.8 m high

b. Debris flow 43 - west side of debris flow basin

c. Debris flow 43 - looking north up canyon, note east bush is 0.9 m high

d. Debris flow 43 deposit- near the basin

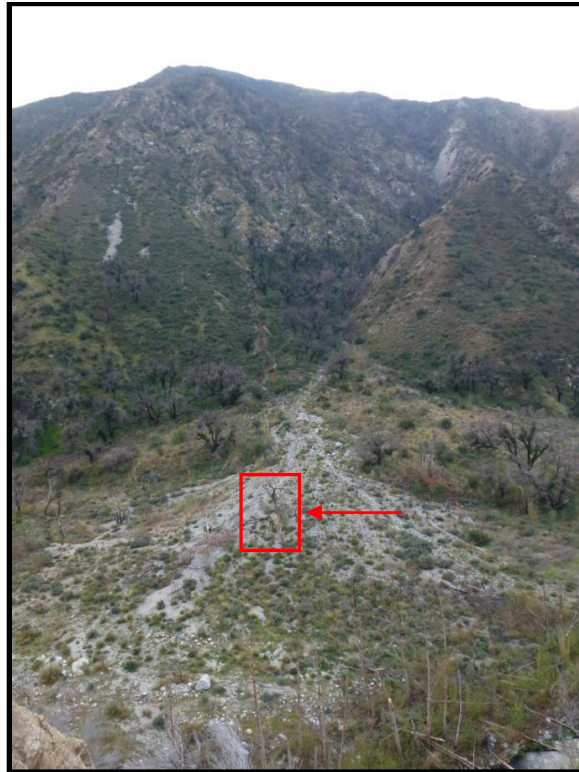
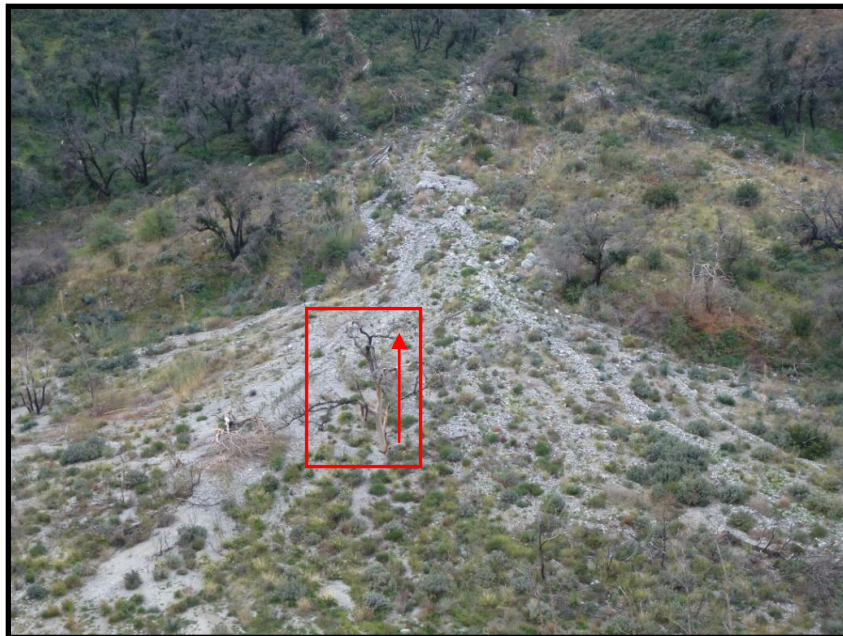
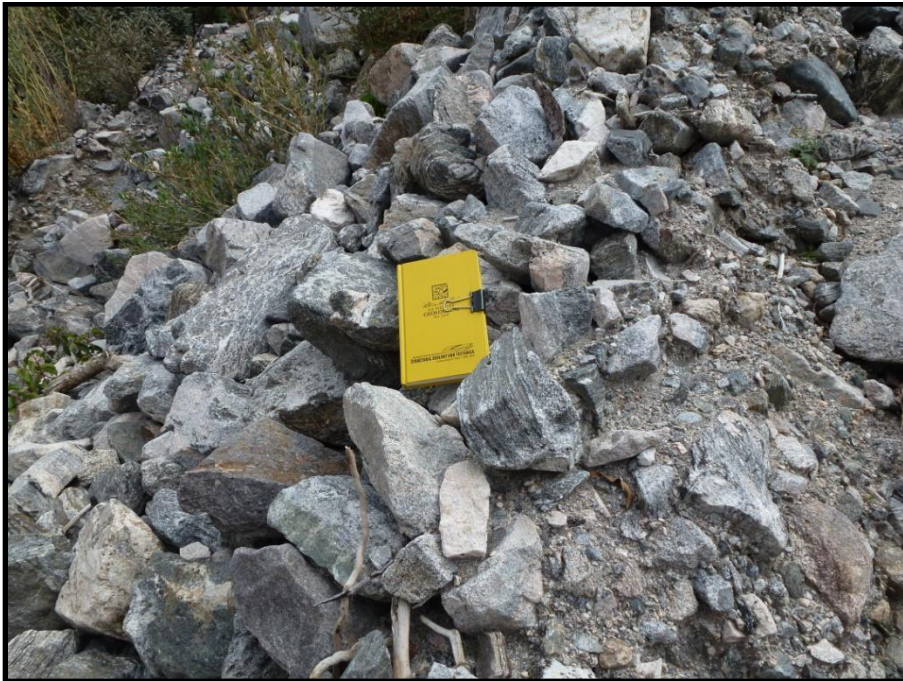
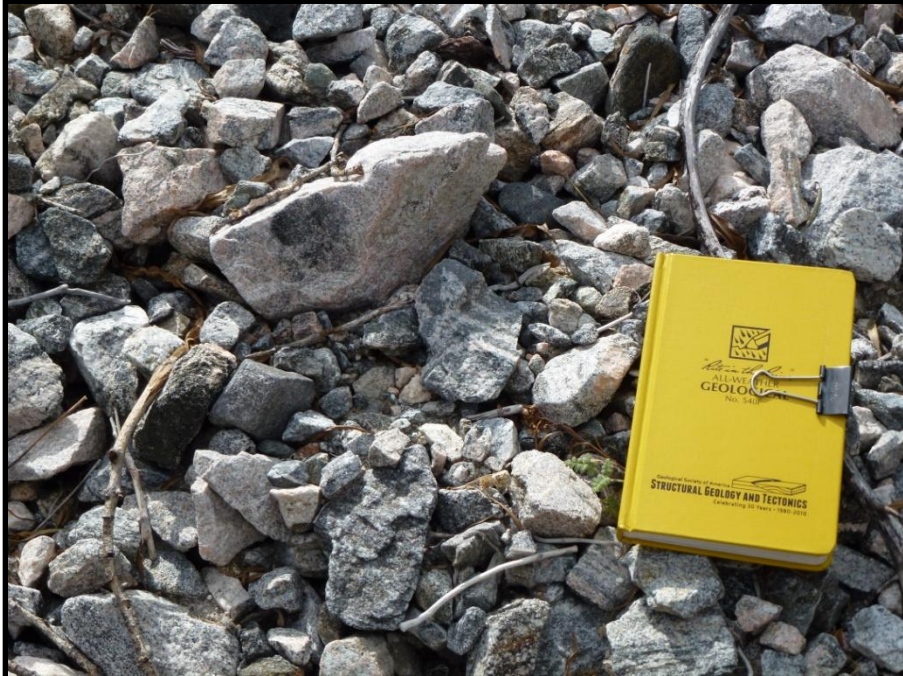
Figure 5. Debris Flow 48 (proximal canyon to Delta Canyon)

a. Debris flow 48 - looking up north canyon from Big Tujunga Canyon Road - note burnt tree in center

b. Debris flow 48 - looking up canyon from Big Tujunga Canyon Road (a closer view) - burnt tree is 3.4 m high

c. Debris flow 48 deposit - center of the deposit

d. Debris flow 48 debris - near the flow toe

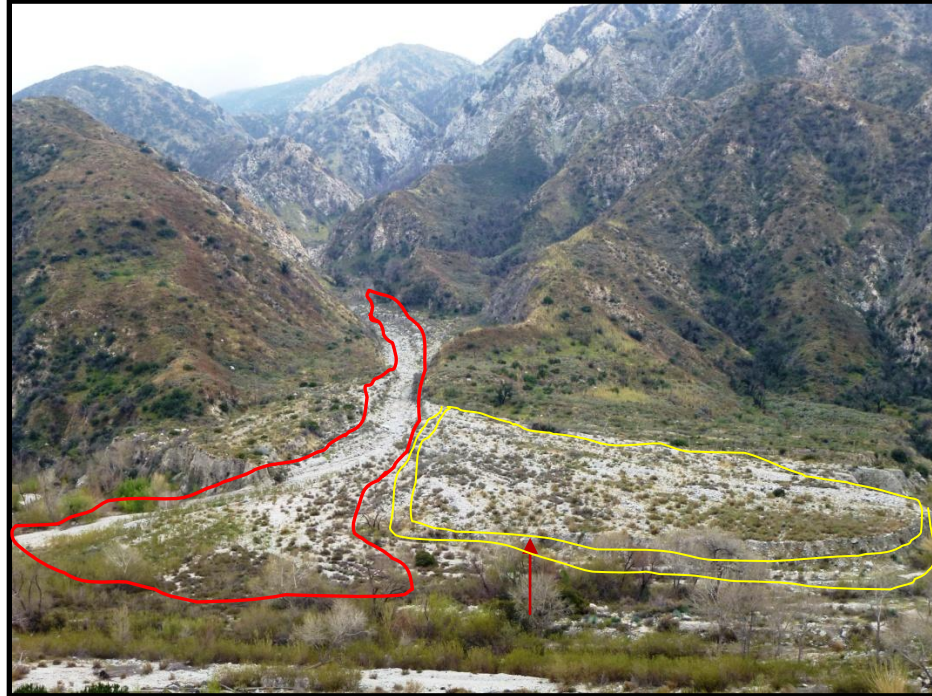
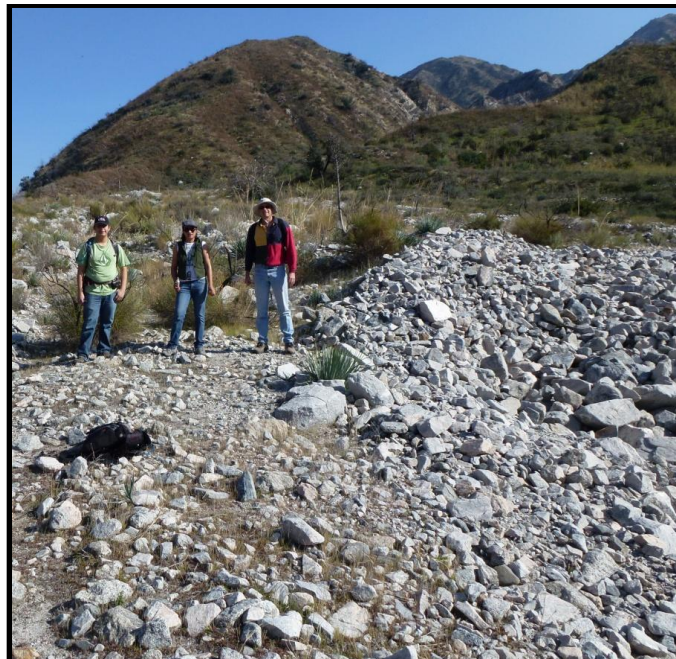
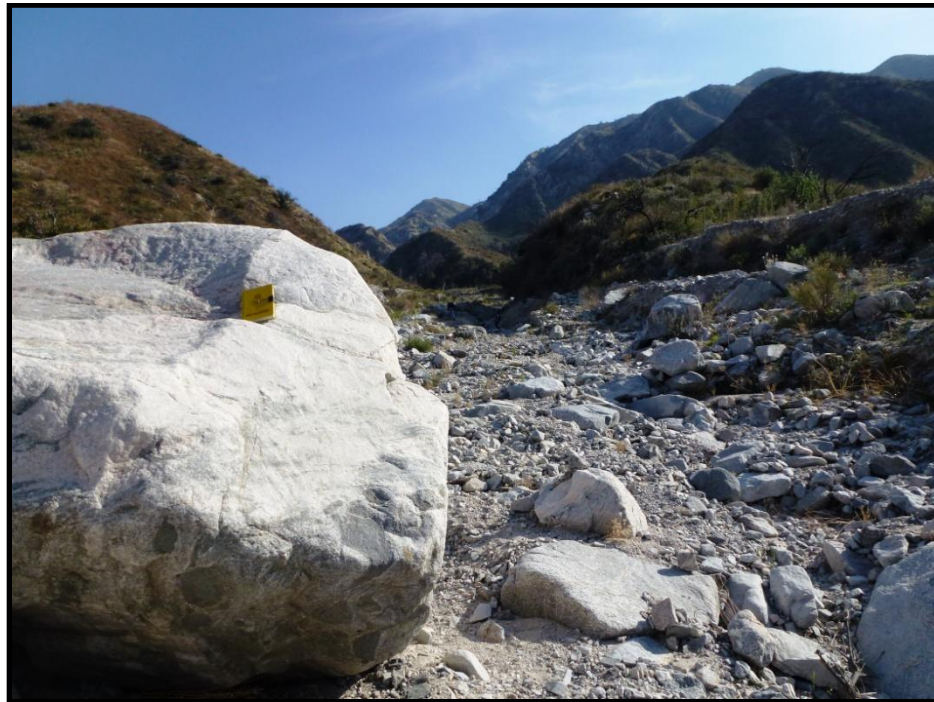
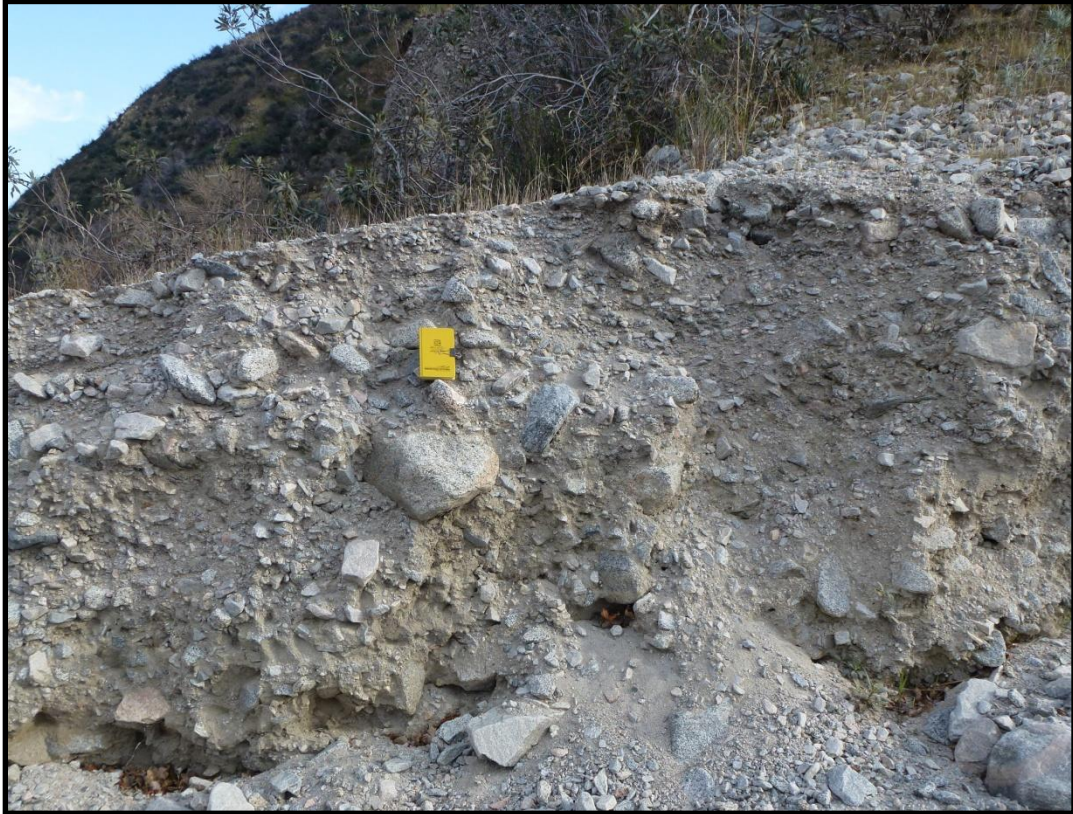
Figure 6. Debris Flow 49 (Delta Canyon)

a. Debris flow 49 - looking south up canyon from Big Tujunga Canyon Road (outline is active debris flow) tree in middle of photo is 3.7 m high. Note the previous debris flow deposits on the left of the photo in yellow

b. Debris flow 49 - looking south up from the east side, field assistants: Bryan Sanchez, Erica Rincon (CSUN Geological Sciences students), and Eric Ahlstrom

c. Debris flow 49 debris - looking south up canyon, mid-flow

d. Debris flow 49 - large boulder on east side of mid-flow

d. Debris 49 deposit on west canyon side wall
