CALIFORNIA STATE UNIVERSITY, NORTHRIDGE

POST-FIRE DEBRIS FLOW EROSION
IN THE SAN GABRIEL MOUNTAINS, CALIFORNIA:
EVIDENCE FROM THE STATION FIRE, 2009

A thesis submitted in partial fulfillment of the requirements
For the degree of Master of Science
in Geology

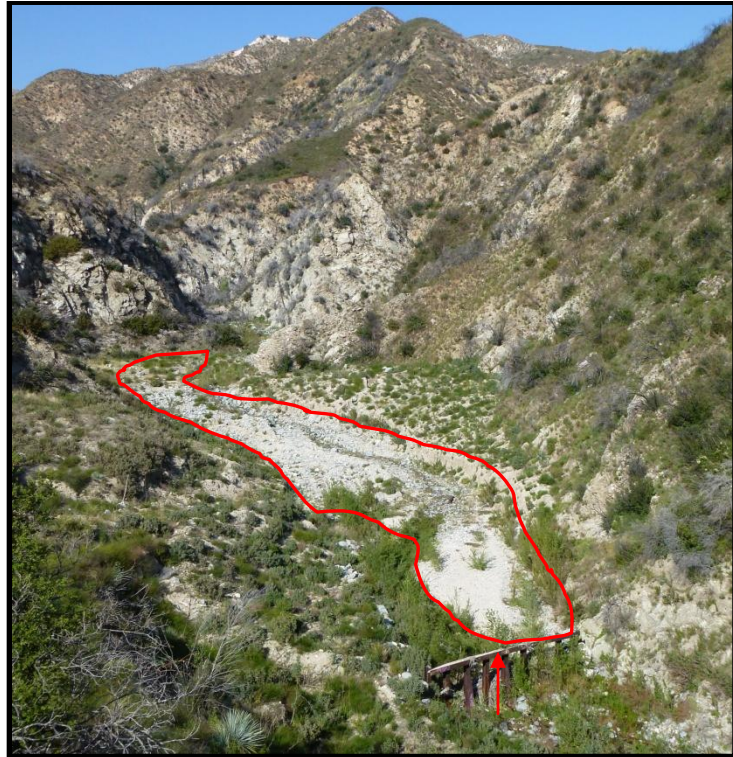
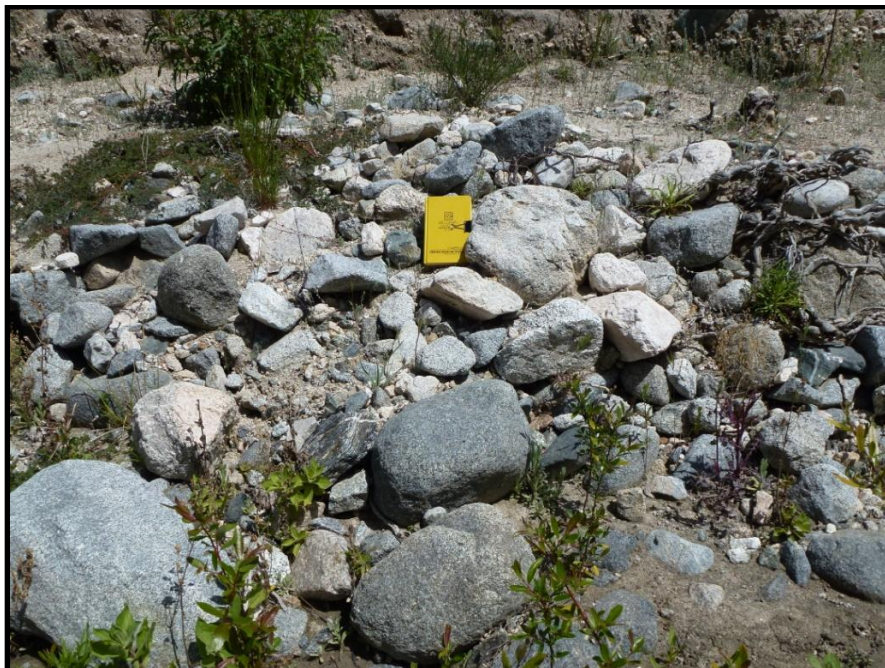
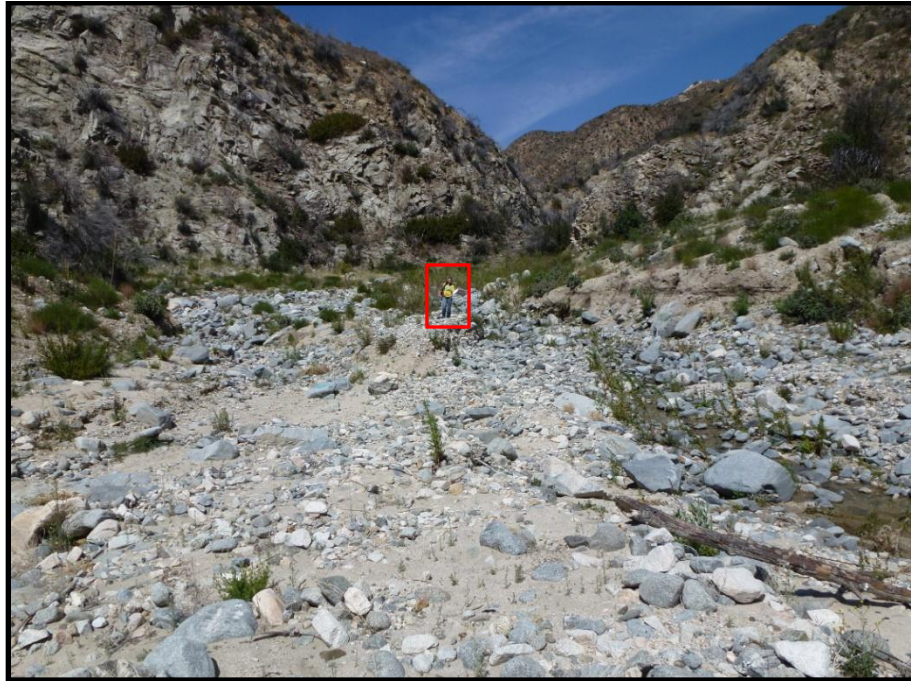
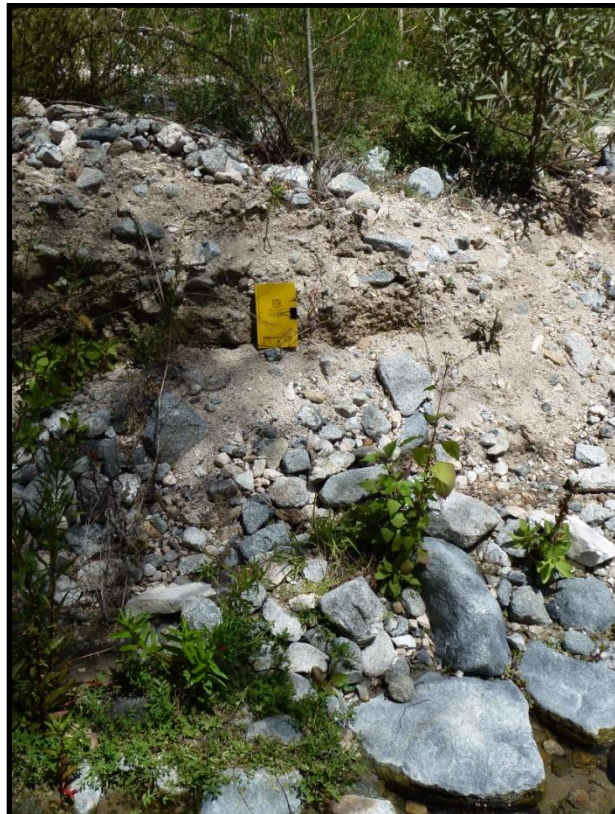
Figure 7. Debris Flow 50 (Vogel Canyon)

a. Debris flow 50 - Looking north from Big Tujunga Road - outline is flow deposit, note the debris gate (2.8 m high)

b. Debris flow 50 deposit - mid-flow

c. Debris flow 50 - looking north from mid-deposit, field assistant: Emelie Traub from LA Valley College

d. Debris flow 50 deposit on east - mid-flow deposit

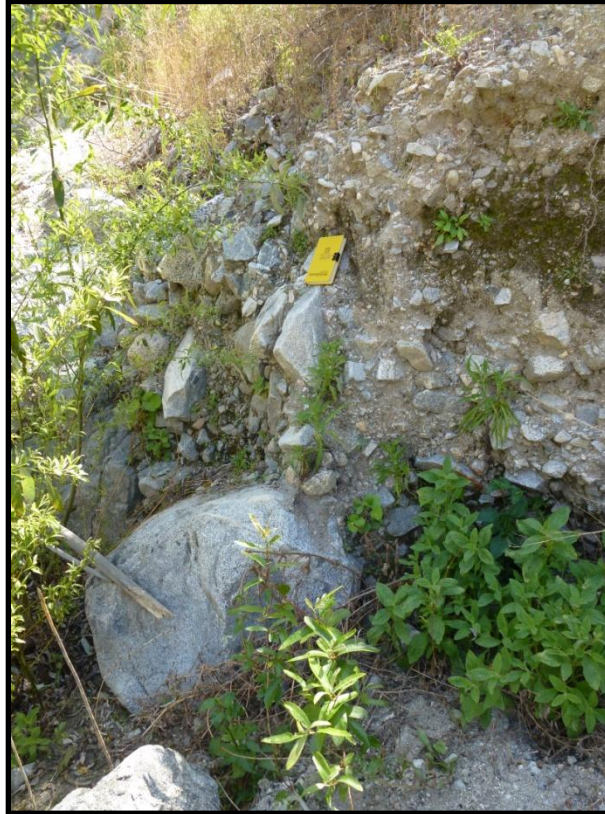
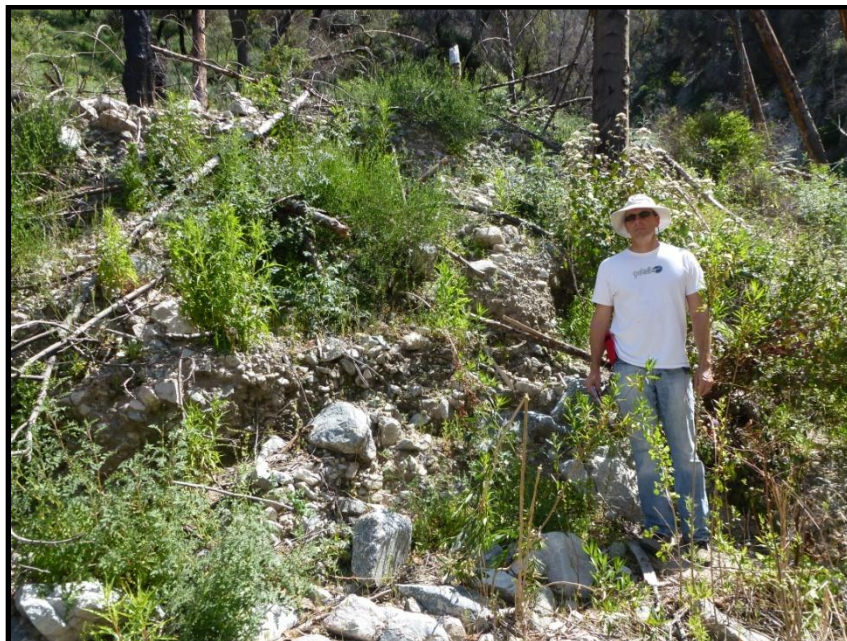
Figure 8. Debris flow 52 (Stone Canyon)

a. Debris flow 52 - west middle deposit

b. Debris flow 52 - west side deposit, field assistant: Eric Ahlstrom

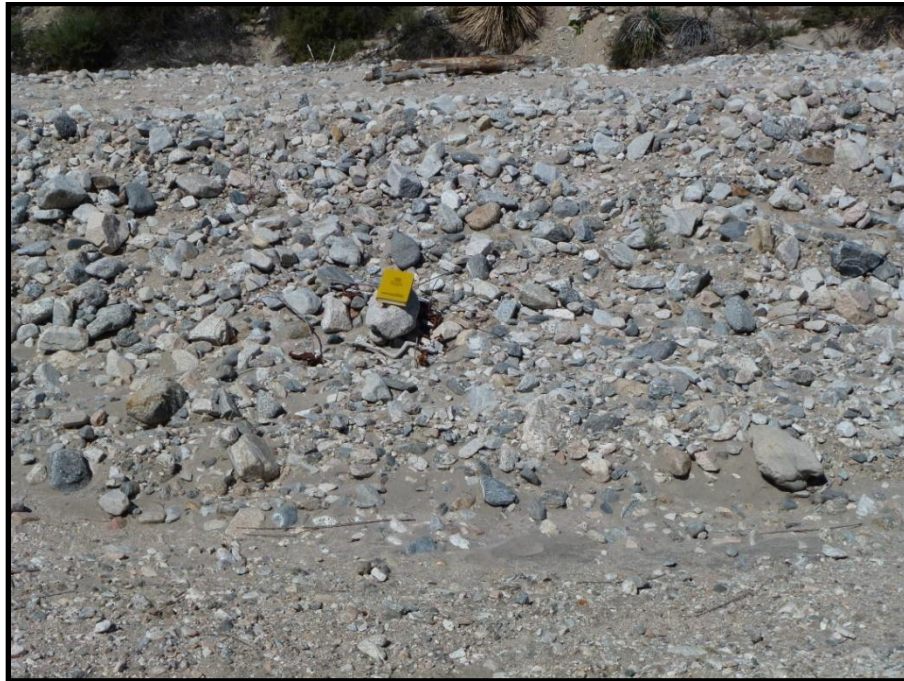
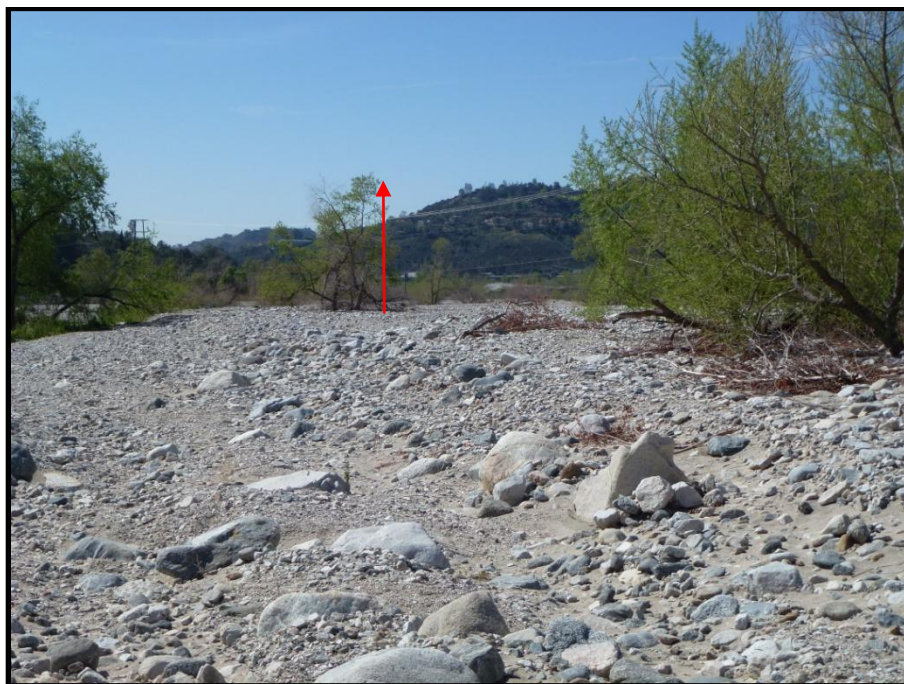
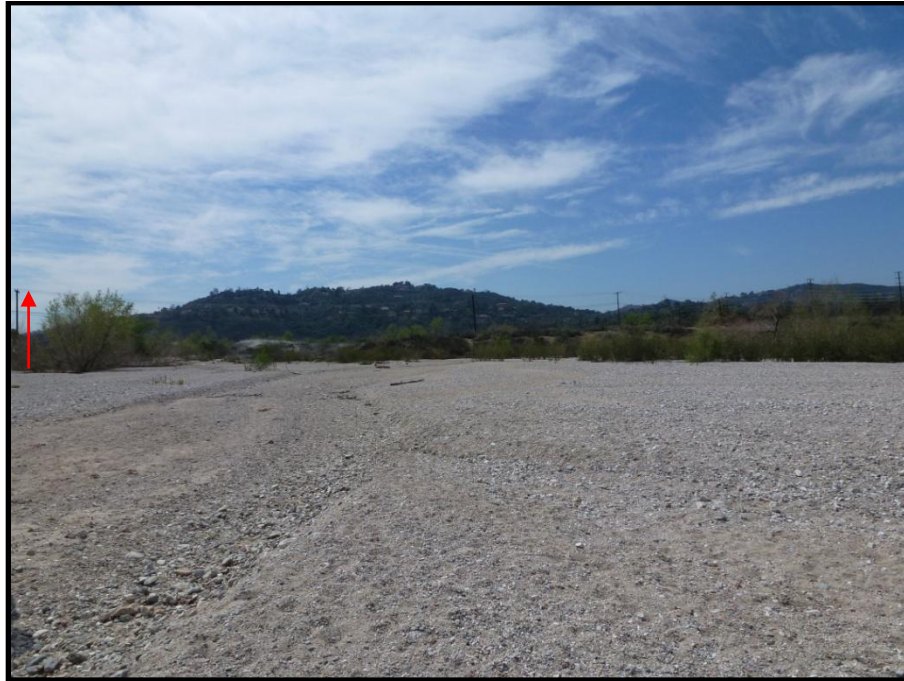
Figure 9. Debris flow 56 (Arroyo Seco Canyon)

a. Debris flow 56 deposit - west side, middle of the deposit

b. Debris flow 56 - looking south to debris flow basin, note tree (4 m high) in center of deposit

c. Debris flow 56 - looking further down south to debris flow basin - note telephone pole (3.7 m high) on the east side
